1st International Forum on the Decommissioning
of the Fukushima Daiichi Nuclear Power Station

Fukushima Daiichi Nuclear Power Station : Current Status and Outreach

1. Current Status of Fukushima Daiichi NPS

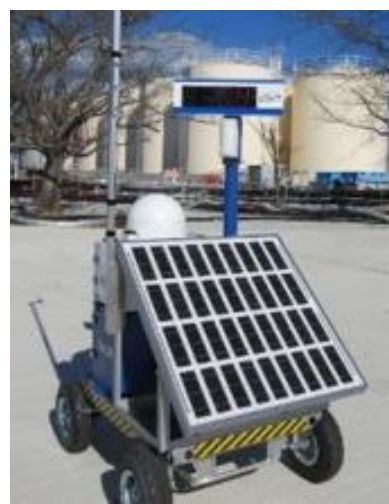
Location of sampling points, dust monitors and monitoring posts

- Dust monitors on the operating floor
- ▲ Dust Monitors
- Monitoring Post
- Sampling points in the sea area

Installation of dose-rate monitors

- System visualizing real time dose data in place.
- Data display monitors (86 points) placed where workers can easily access. Continuous dust monitoring data also shown on display.

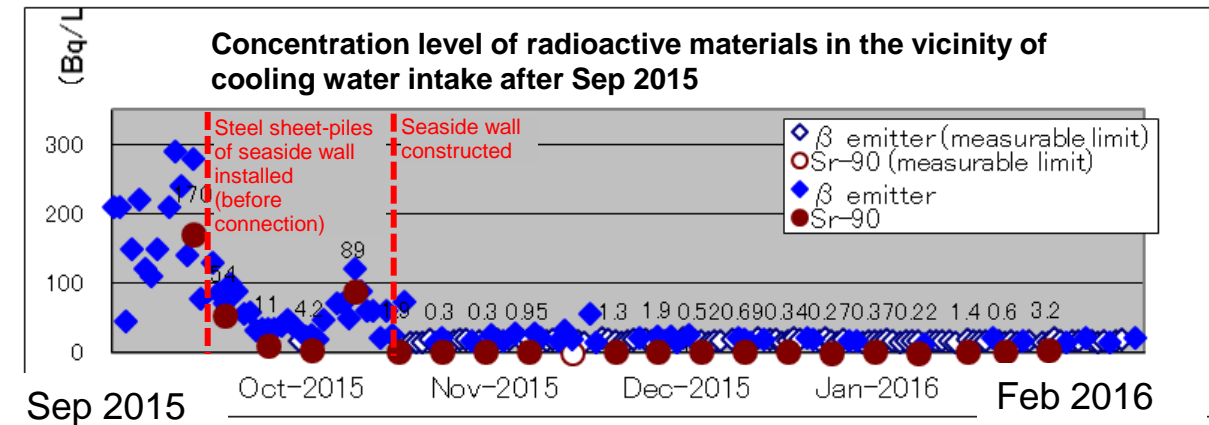
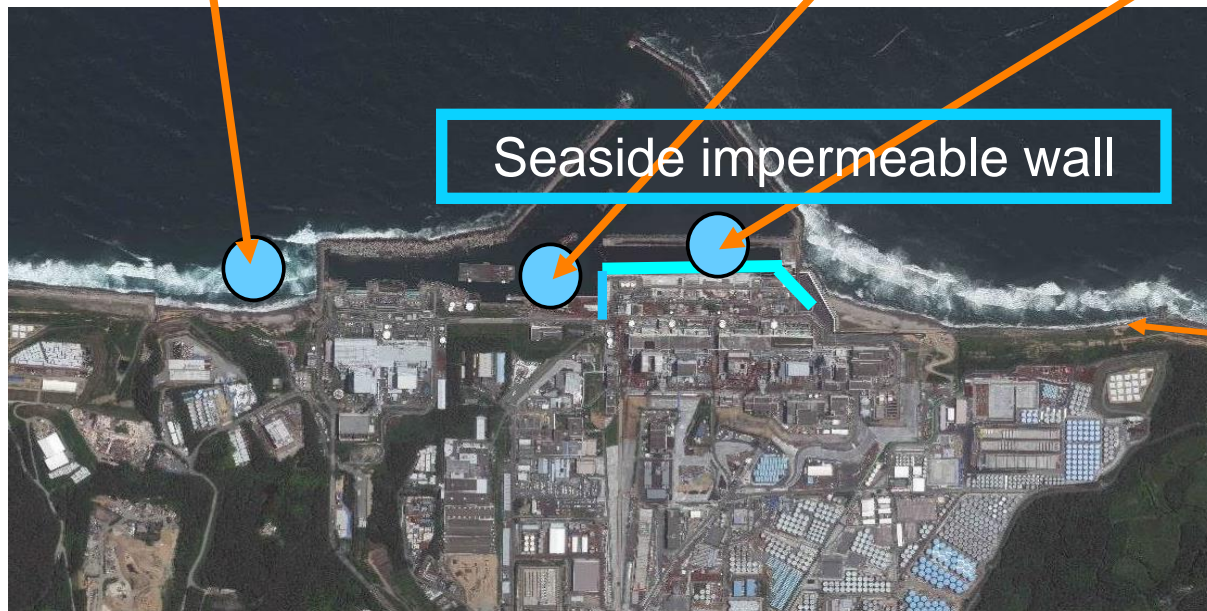
Radioactive Material Concentration In Sea Area Decreased By 1/1,000,000 After The Accident

Concentration Limit Specified by the Rule

- Cesium 137: 90Bq/L - - - -
- Cesium 134: 60Bq/L - - - -

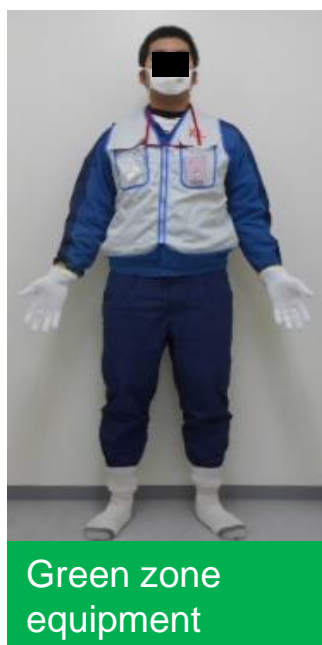
Personal protective equipment in each zone

Full-face respirator

Half-face Respirator

DS2 Mask
