The 2nd International Forum on the Decommissioning of the Fukushima Daiichi Nuclear Power Station

Current Status and Challenges at Fukushima Daiichi Decontamination and Decommissioning

July 3, 2017

President of Fukushima Daiichi Decontamination and
Decommissioning Engineering Company,
Tokyo Electric Power Company Holdings, Inc.

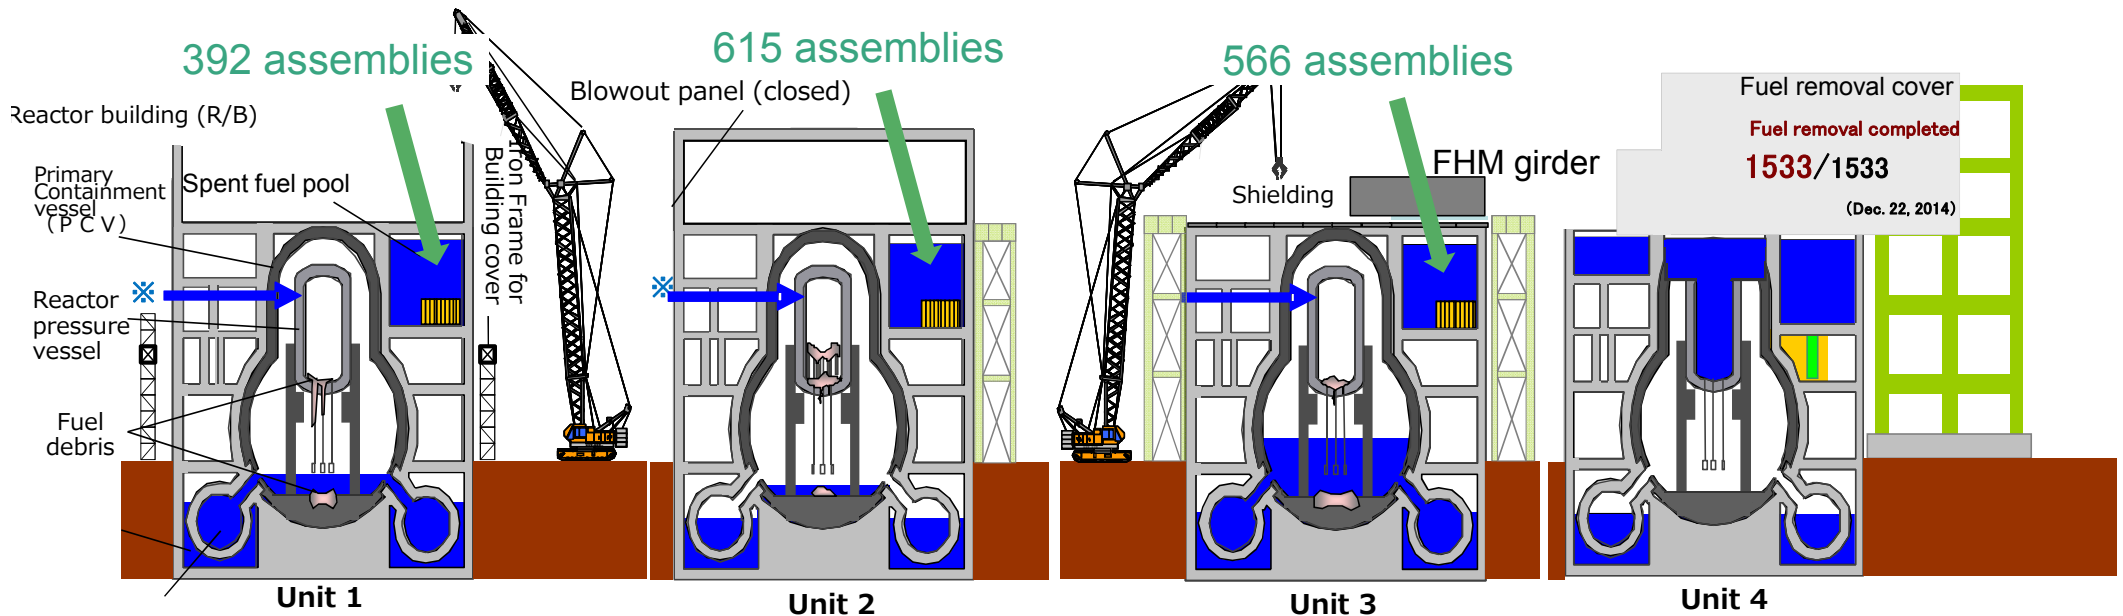
- All reactors are in cold shutdown condition.
- Plant parameters including RPV and PCV temperatures are monitored continuously 24 hours/day.

Values as of 11:00 am on June 9, 2017

Temperature at the bottom of the pressure vessel	Temperature inside the containment vessel	Fuel pool temperature	Reactor coolant volume
Unit 1	21 °C	21 °C	25 °C	3.0 m ³ /hour
Unit 2	27 °C	28 °C	26 °C	3.0 m ³ /hour
Unit 3	24 °C	24 °C	26 °C	3.0 m ³ /hour
Unit 4	—	—	23 °C	—

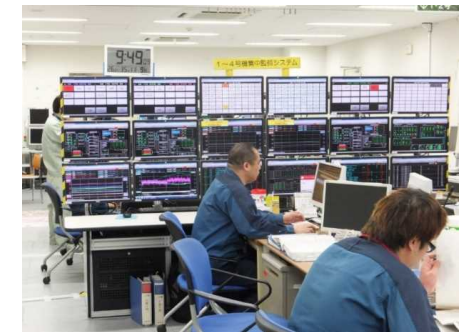
(2) Monitoring Level in the Sea

- Compared to the situation just after the accident, the current level of radioactivity has been lowered to parts per hundred thousand, to per million.
- The concentrations outside the port are substantially below regulation limits.
- Concentration levels decreased further after closure of the sea-side impermeable wall.

Regulation Limit

- Cesium 137: 90Bq/L
- Cesium 134: 60Bq/L

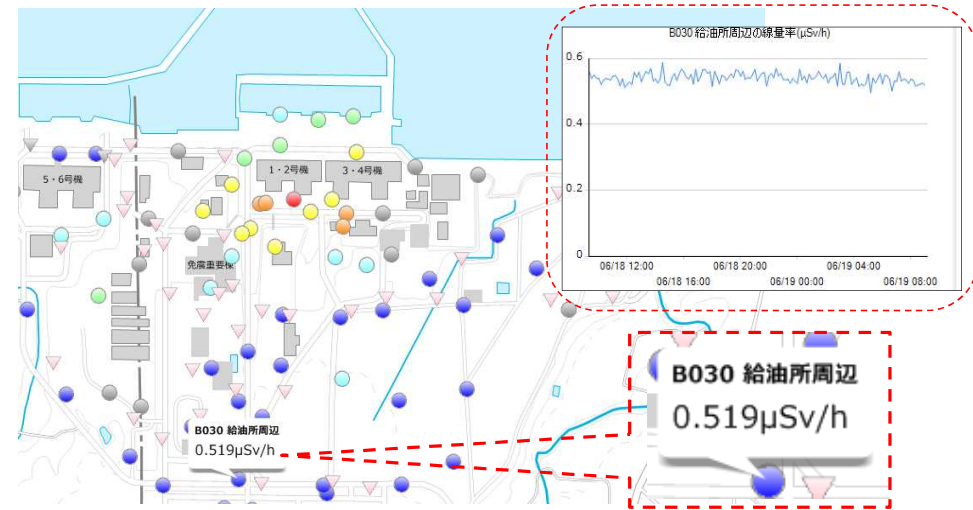
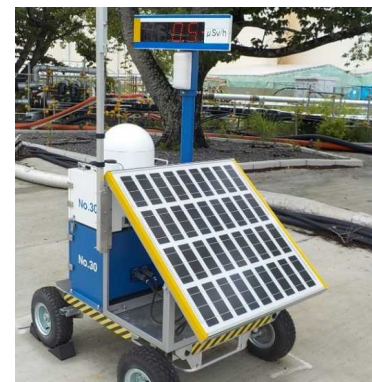
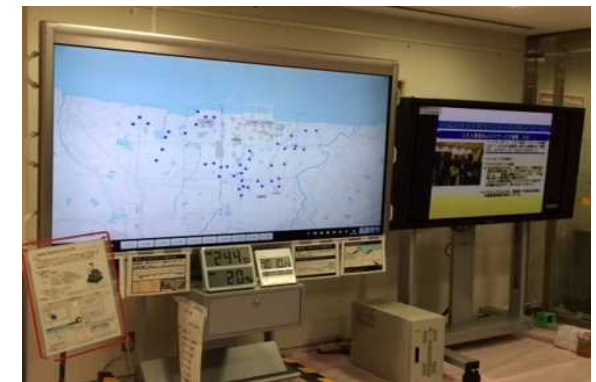
Installation of dose-rate monitors

- System visualizing real time dose rate in place.
- Dose rate display monitors (about 90 points) and dust monitors are placed where workers can easily access.

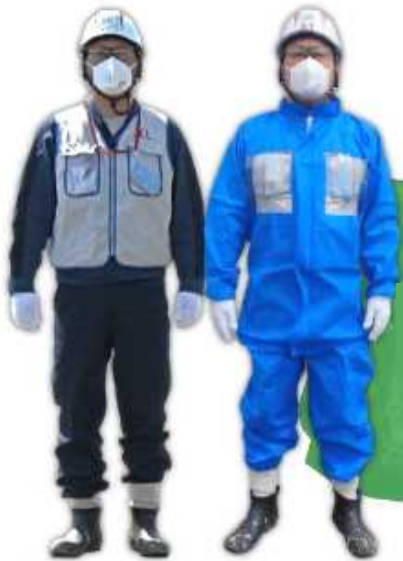
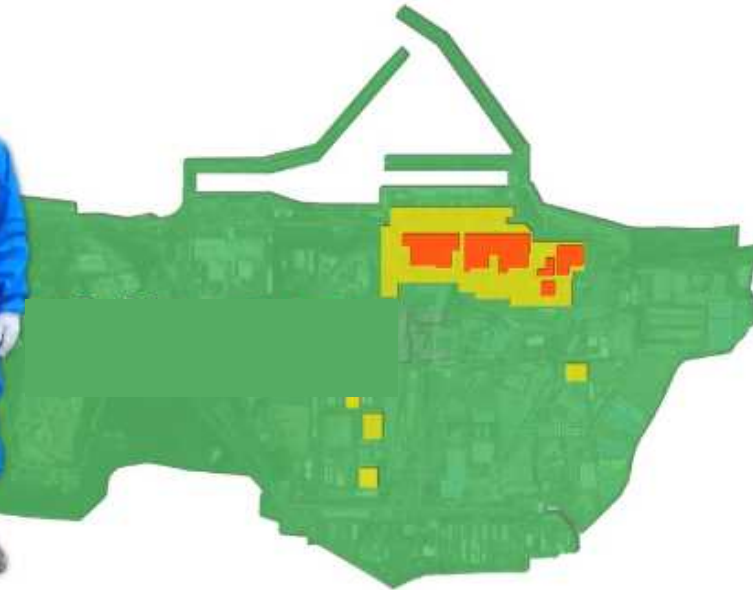
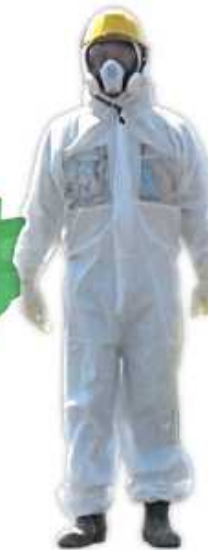
Personal equipment in each zone as of Mar. 2017

Area where people can work in general uniforms (dust mask) **【95% of the site】**

Area where people should work in protective gears (full-face respirator or half-face respirator)

- As a result of radiation reduction measure, workers don't have to wear full-face respirator or half-face respirator anymore in most parts of the site.

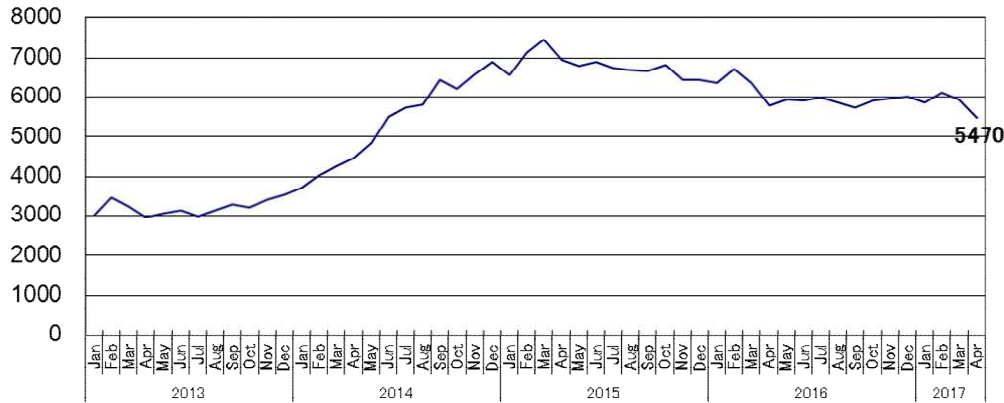
Changes in number of workers

- Number of workers (TEPCO employees and contractors) per weekday engaged in work is 5,470 as of Apr. 2017.
- Percentage of workers from local area is approx. 55% as of Apr. 2017.

Change in the average number of workers (actual value) per weekday in the months following 2013.

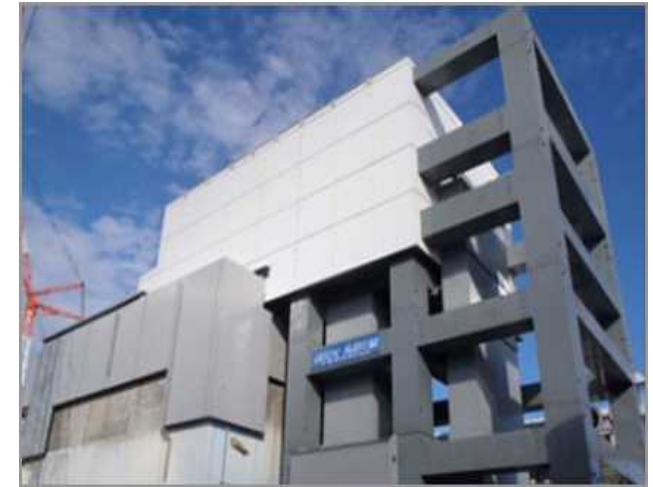
November 12, 2013: Completion of fuel removal facility
(The volume of steel used is equivalent to those of Tokyo Tower)

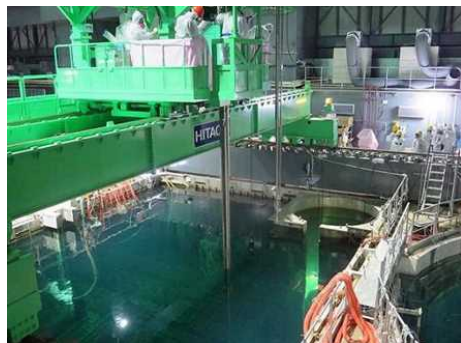
Process of removing fuel rods at SFP Unit 4

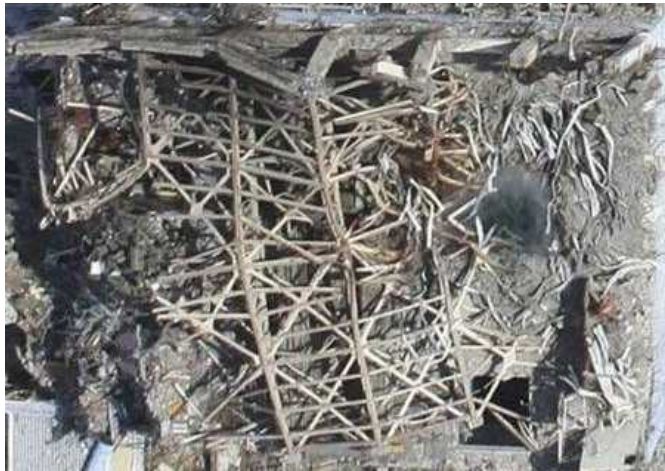
Before removal of large pieces of rubble

Mar. 2013

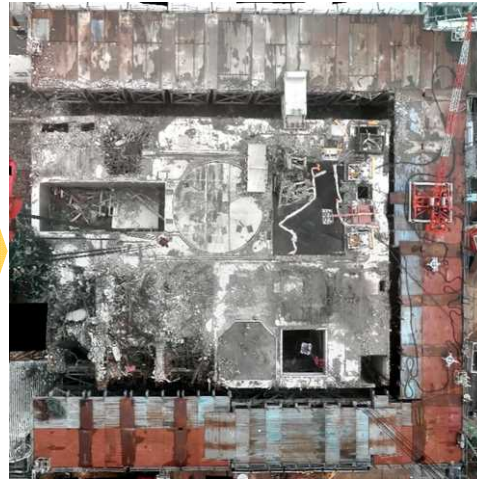
After removal of large pieces of rubble

Feb. 2016

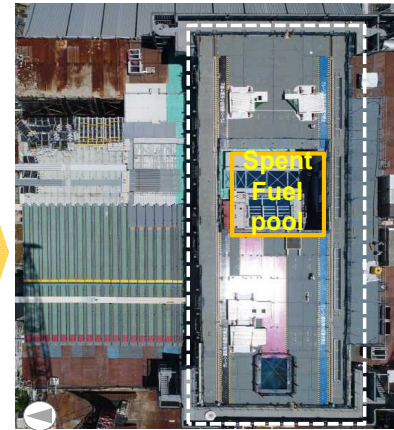
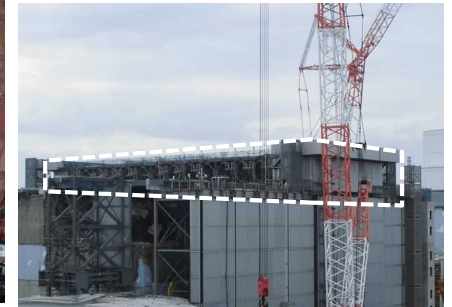
Installation of a basis for Fuel Removal Cover

Jun. 2017

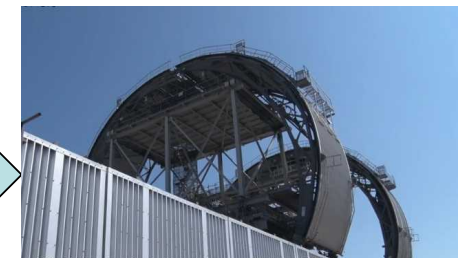
Fuel removal cover
(Drill for installment at Onahama)

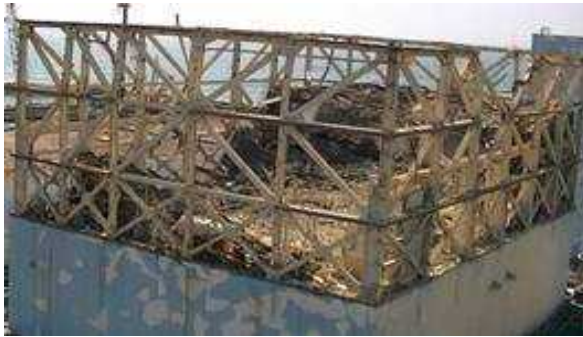
Northwest side
(Jun. 2011)

- Building cover was installed in Oct. 2011 to prevent dispersion of radioactive materials.
- Removal of panels was completed in Nov. 2016 toward removal of spent fuel. Removal of posts and beams was completed in May. 2017.
- Fuel removal will start in FY 2020.

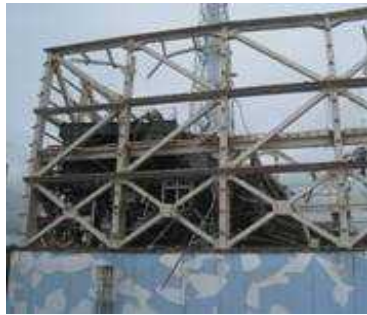
Southeast Side
(Jun. 2011)

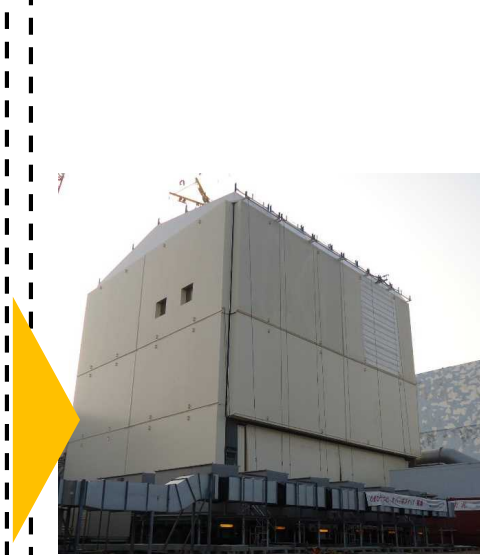
Complete installation
of building cover
(Oct. 2011)

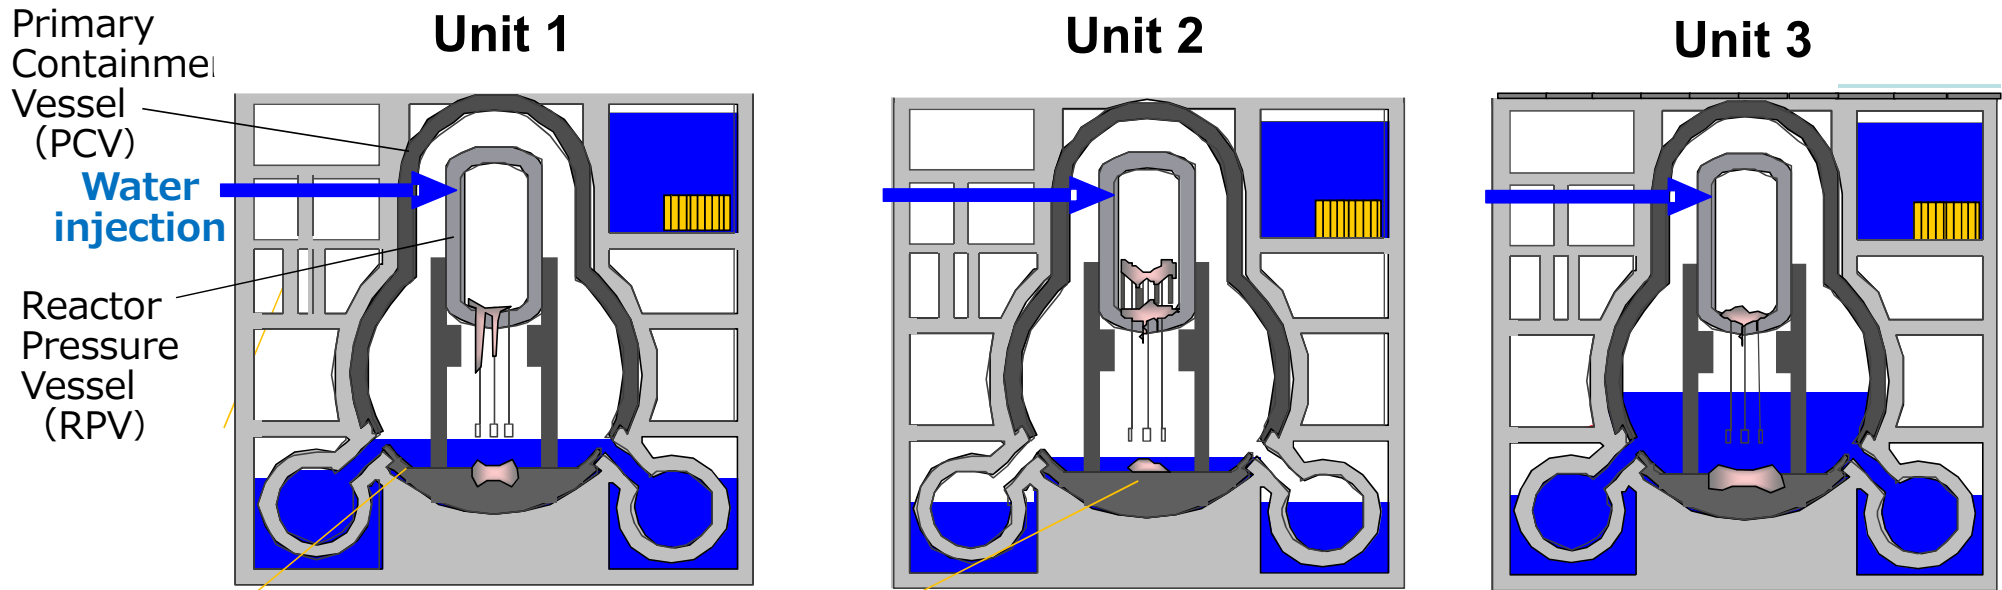
(1) Assumed Distribution of Fuel Debris

- It is assumed that at Unit 1, almost all fuel debris has dropped to the pedestal.
- It is assumed that at Unit 2 and 3 that some of fuel debris has dropped to the bottom of RPV and the bottom of PCV, while others are likely to have remained in the reactor cores.
- At Unit 3, underwater investigation is planned due to the high water level inside PCV.
- Distribution of fuel debris is assumed comprehensively based on the analysis of accident development and the results of the investigation inside each PCV etc.

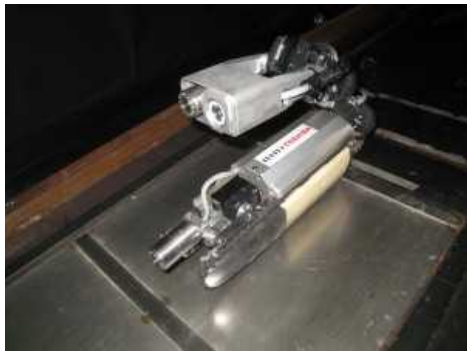
Survey by a robot

- Investigation inside the PCV and at the bottom of the RPV was conducted.(from Jan. to Feb. 2017)
- X-6 through-hole was used as a path for devices to go inside.
- Equipment at the lower part of the RPV and the grating were observed.

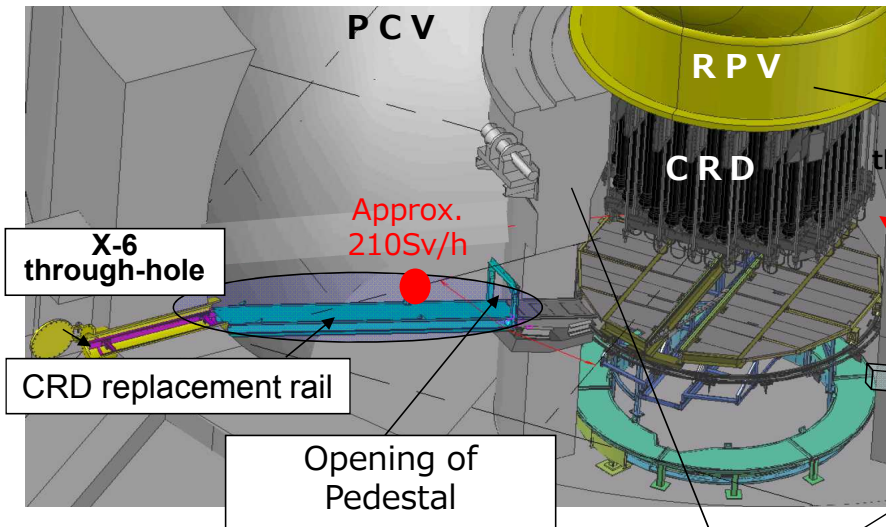
<Obtained information on radiation level through robot exploration>

- Radiation in the reactors is blocked by iron and reactor buildings.
- The measurement of 210Sv/h at the time of Unit 2 PCV investigation on Feb. 16 doesn't mean that radiation had an impact on the environment.

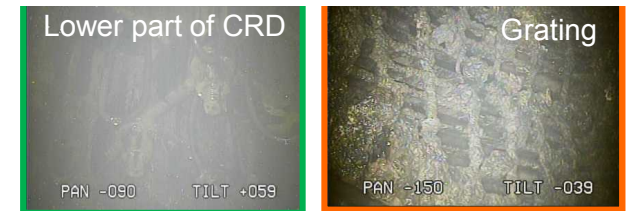
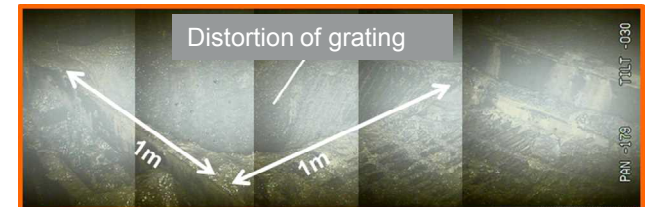
<Photos taken inside the pedestal >

※ Places where fuel debris is presumed to exist

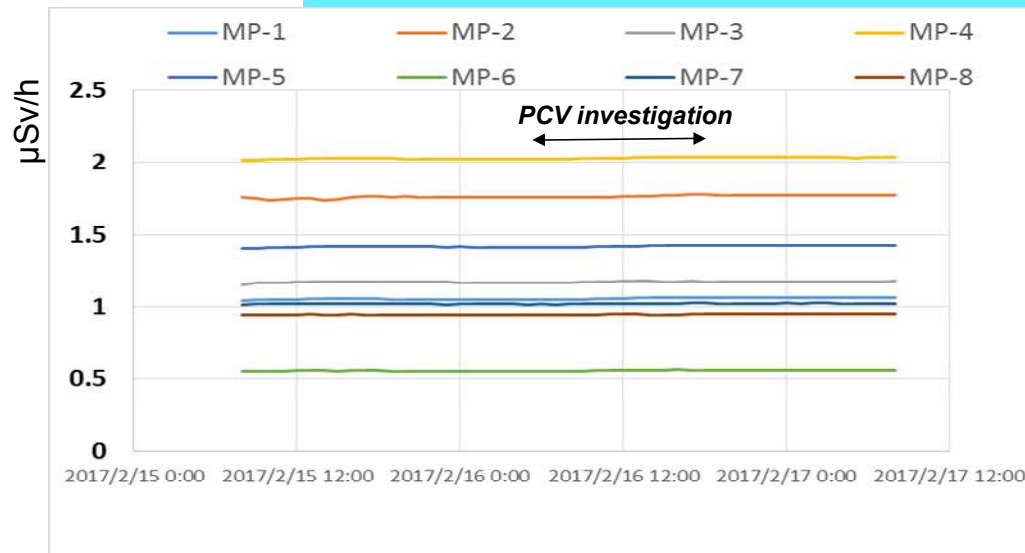
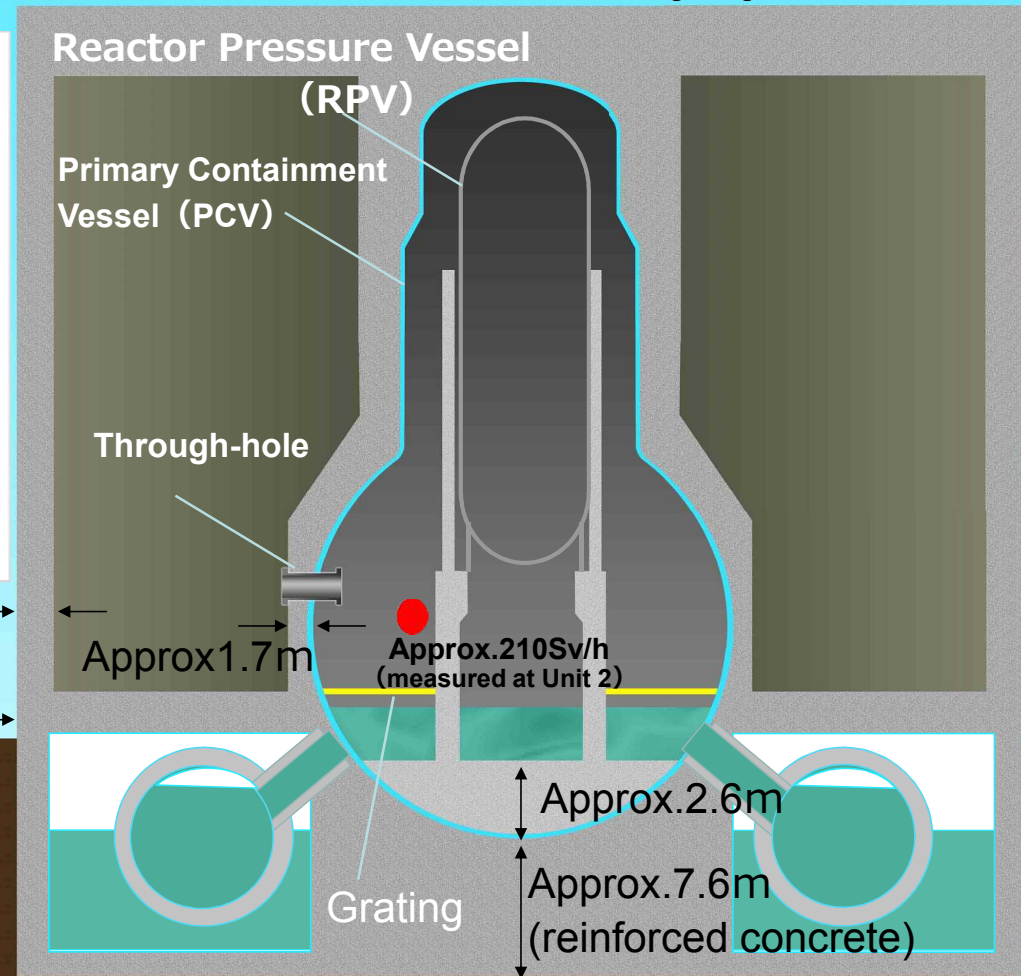
※The data regarding thickness is from Unit1.

Work area in the vicinity of the through-hole at Unit 2 : Approx.0.003~0.007Sv/h (3~7mSv/h)
 Max value of monitoring posts : Approx.0.000002Sv/h (2µSv/h)

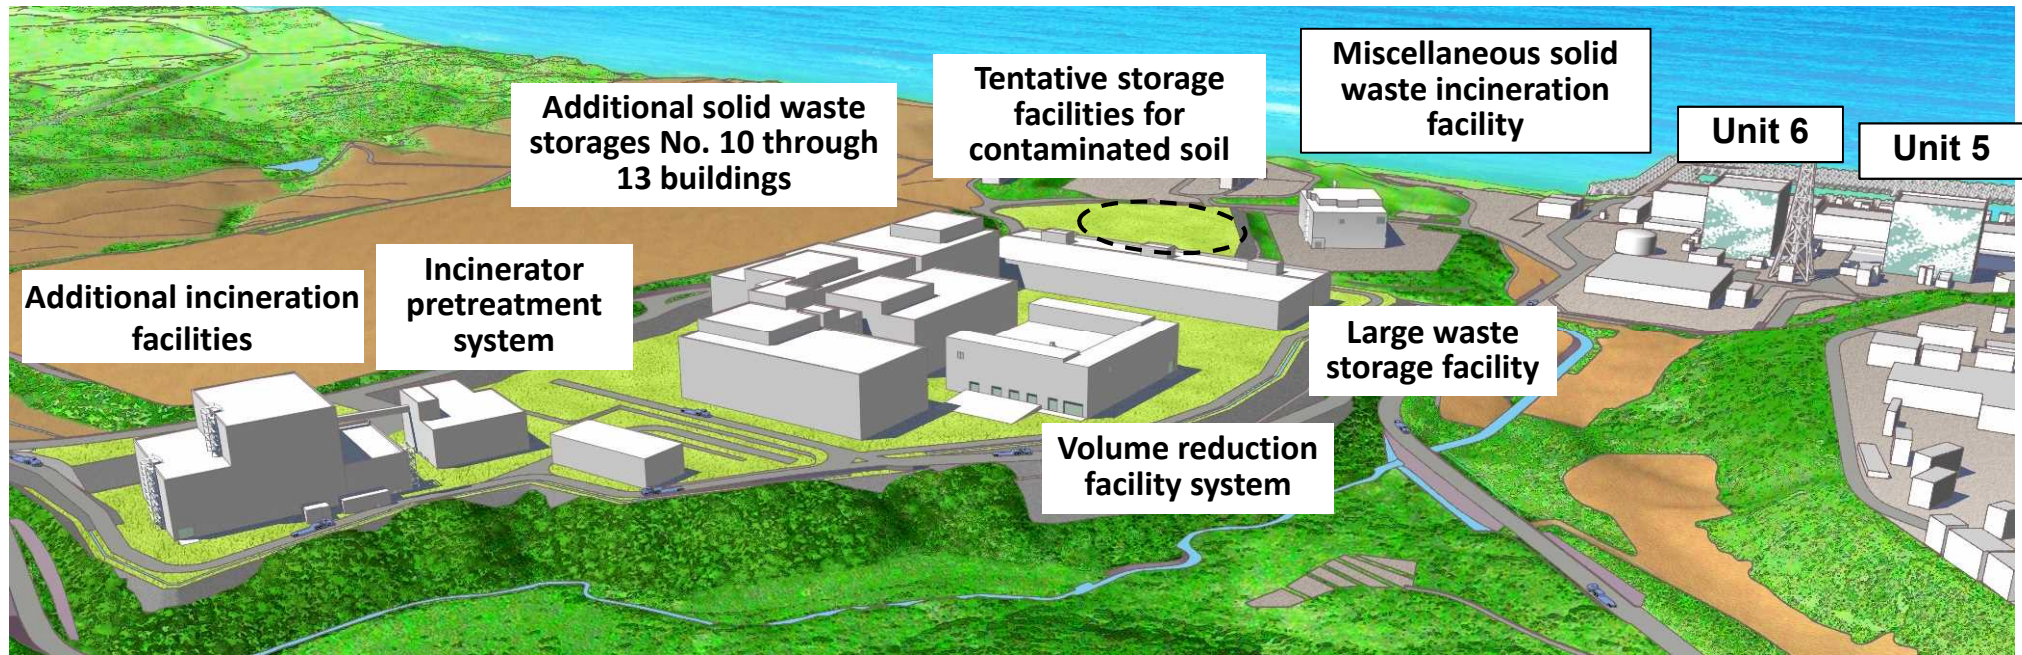
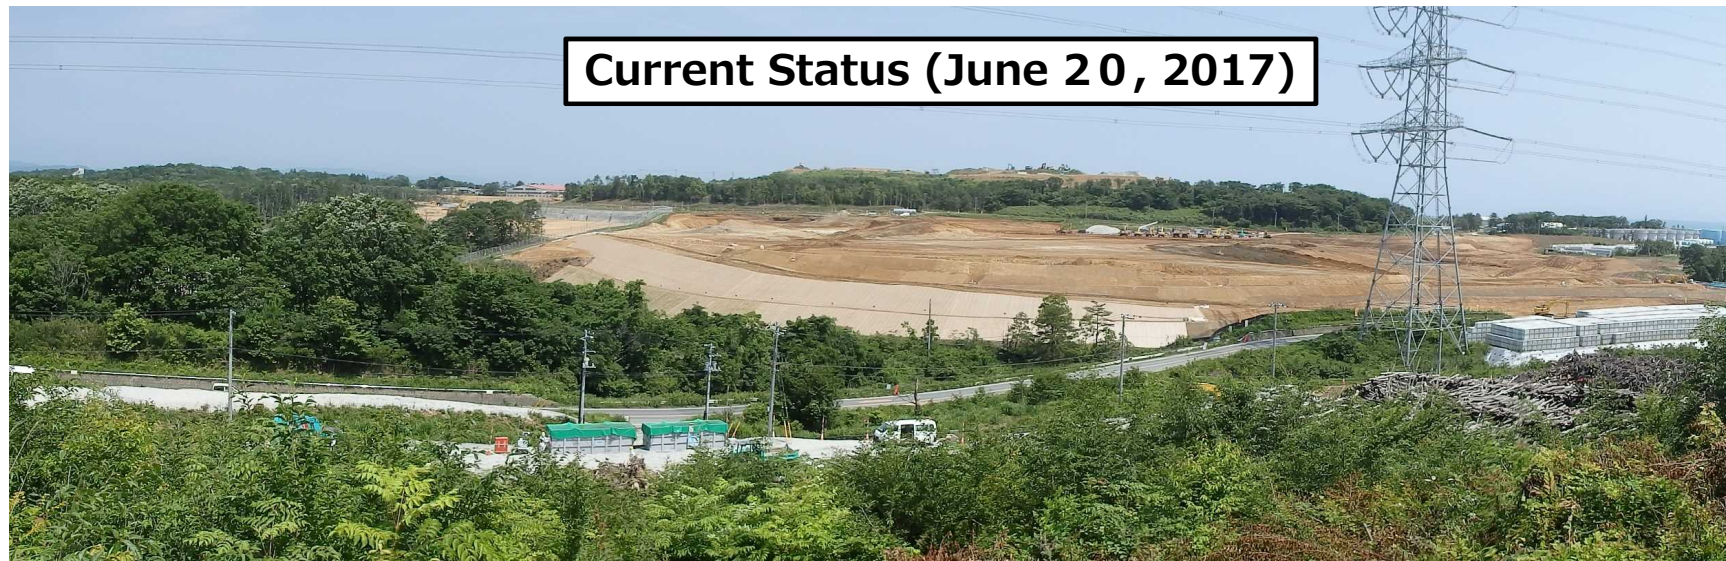
Image of the establishment of systems and facilities
